mirotherm® absorber fact book

Table of Contents

2.1 Test Report No. X111

Customer: Wagner & Co. Solartechnik GmbH – Long term load testing:
Laser welded Cu-Alu absorber thermal-shock test procedure (on arrangement).

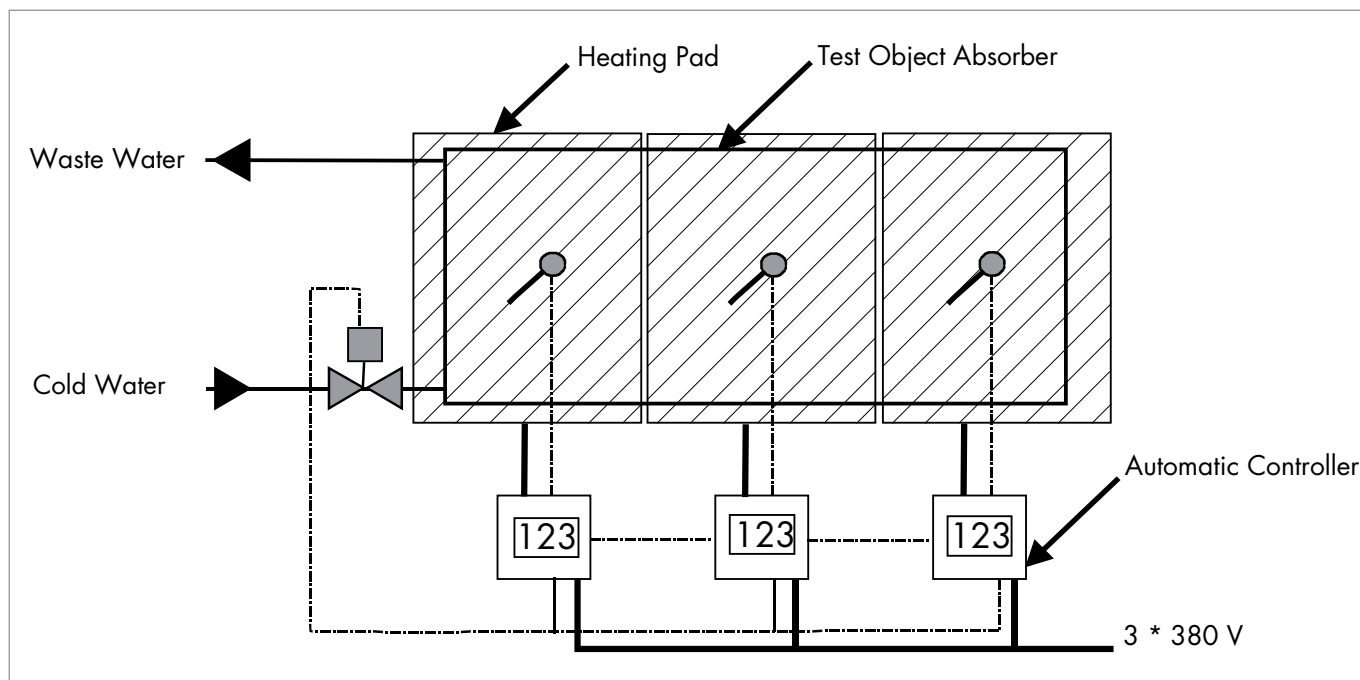
Figure 1: Test setup

The absorber was mounted freely on a horizontal mineral wool base. A heating blanket consisting of 3 synchronized heating zones was laid over the absorber, whereby each heated zone had a separate programmable temperature controller. Cold tap water controlled from a program by a solenoid valve was circulated through the absorber to induce thermal shocks.

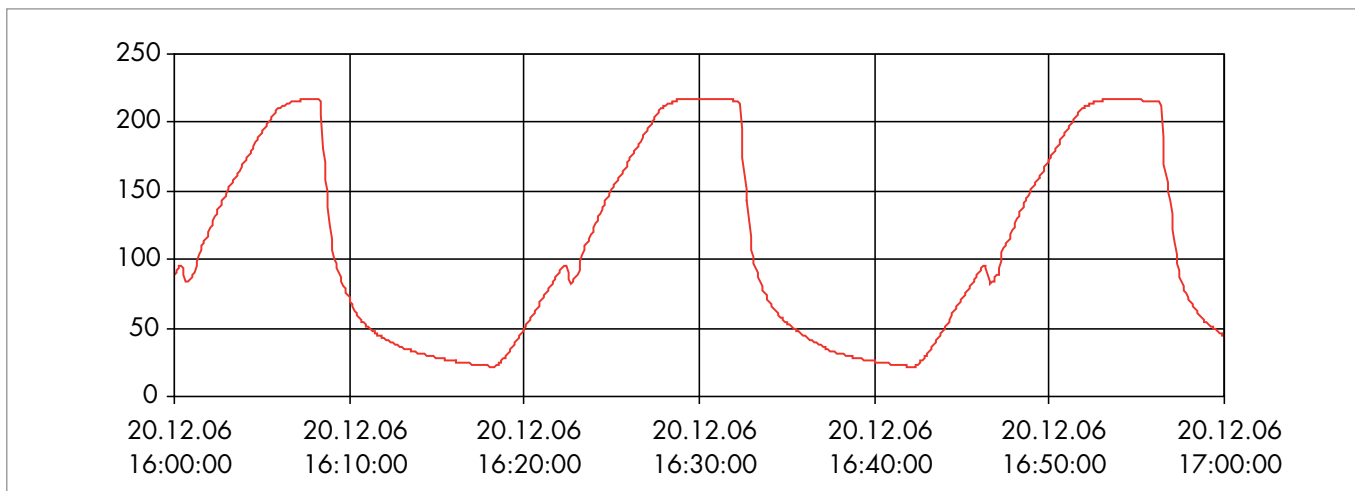
Figure 2: Temperature profile over time of high temperature cycle

For the purpose of temperature logging and control a number of Pt100 sensors were fixed to the absorber (Fig. 3). The following figure shows the temperature profile (high temperature cycle) over the period of an hour. Clearly visible on each cycle approaching 100°C is the boiling of the stagnant water within the piping:

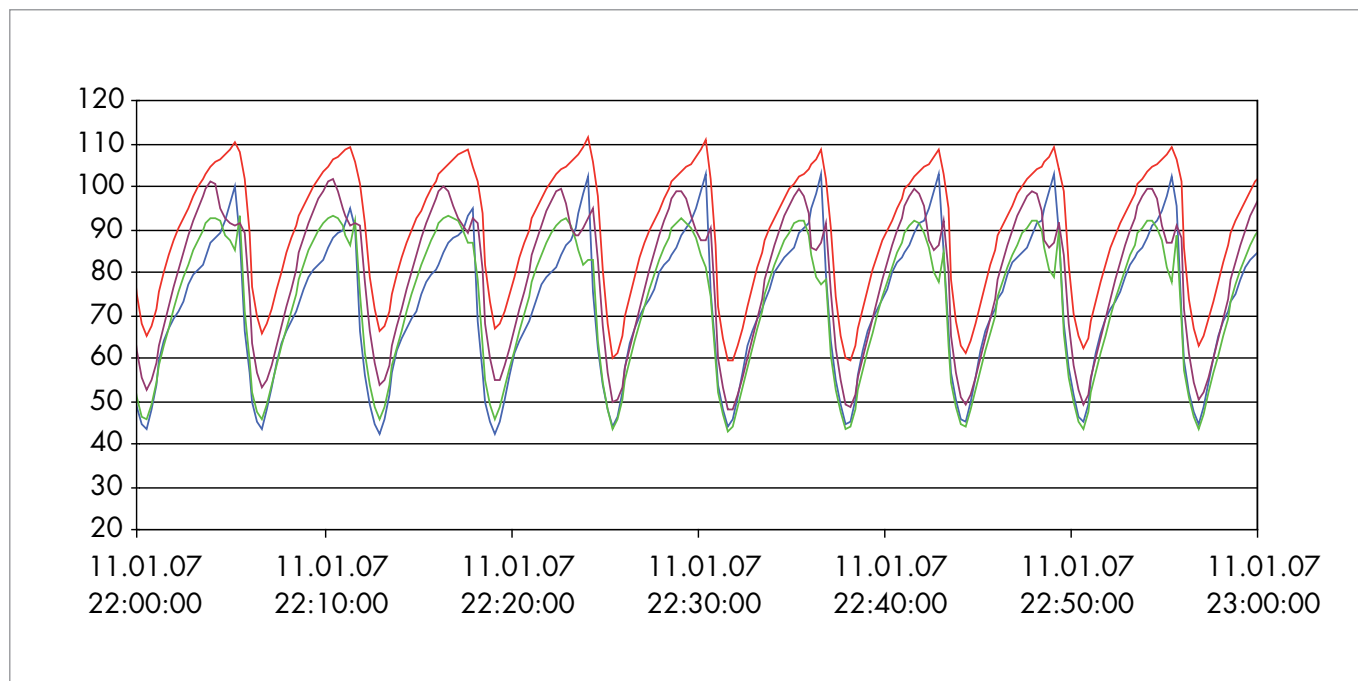
Figure 3: Temperature profile over time of low temperature cycle

keep the total testing time acceptable this measure was abandoned for the low temperature cycling. As is visible in Fig. 3 this scattering of measured temperatures of the absorber are evident yet within the tolerances specified ($100^{\circ}\text{C} \pm 10^{\circ}$).

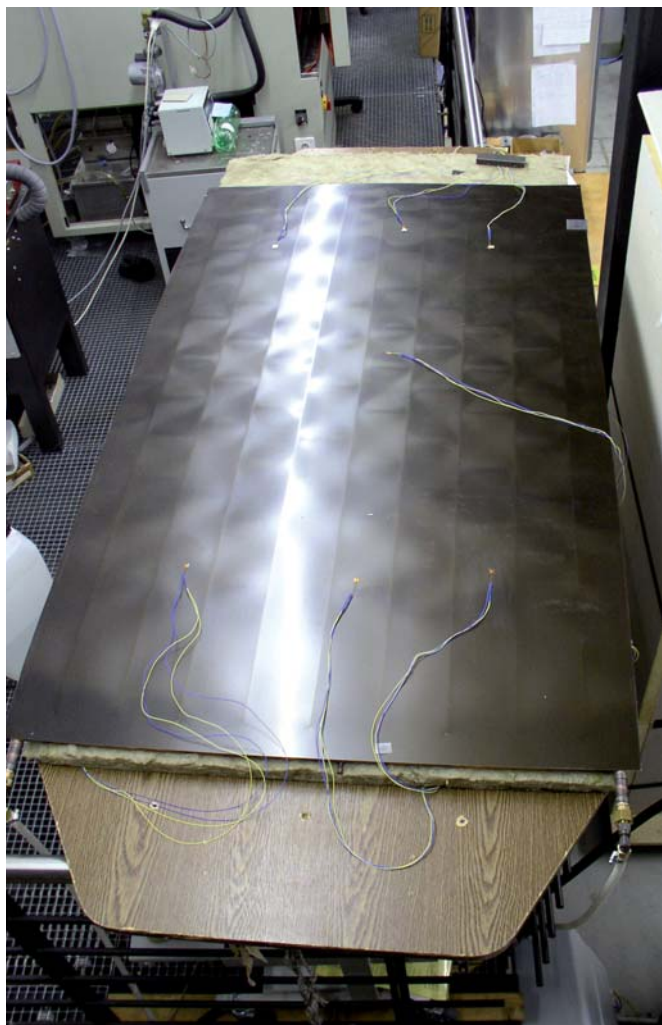
Figure 6: Absorber lying on insulation platform. Various positioned Pt100 sensors visible on absorber surface.

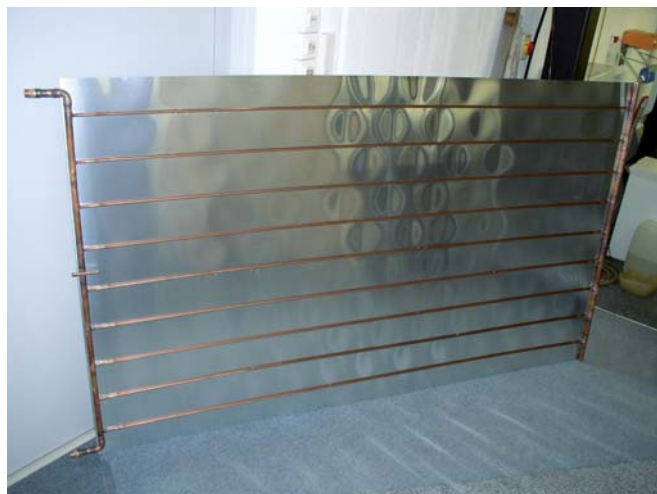
Figure 7: Rear side of absorber.

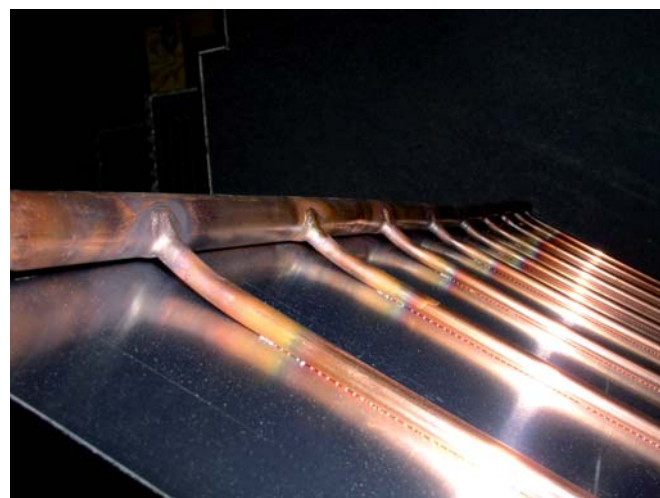
Figure 8: Mildly cranked copper pipe register.

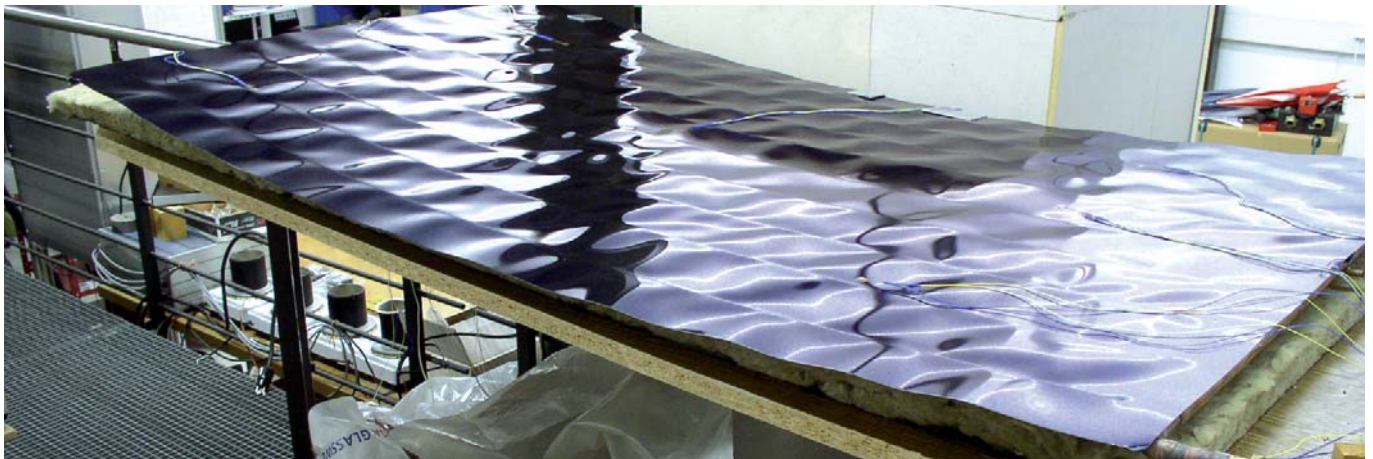
for Al-Cu absorbers as well as a dished curvature over the absorber is readily observed. As far as a visual inspection can reveal, all welded seams were found to be intact.

Figure 9: The typical crumpling pattern is visible already following the first few cycles.

As was observed with earlier experimentation, the crumpling of the aluminum sheet and the overall dished curvature resulting from the bimetallic thermal work stabilized within the first few cycles.

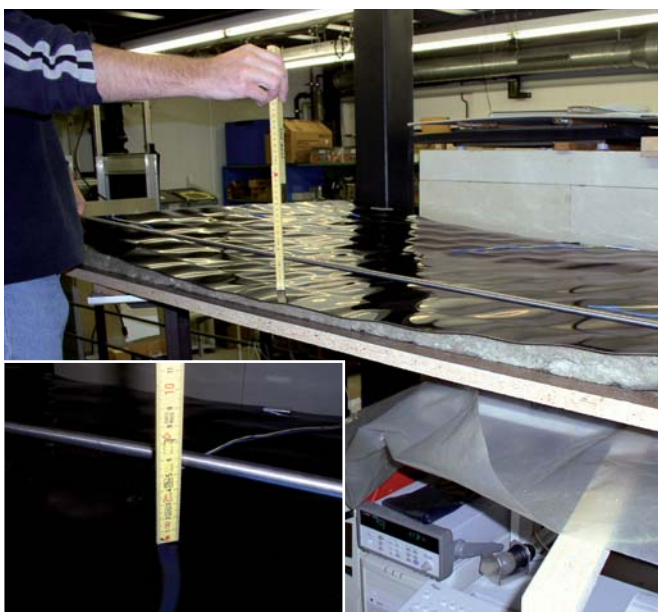
Figures 10 & 11: Significant dished deformation led to an overall curvature with a depth in the range of 5 - 6 cm.

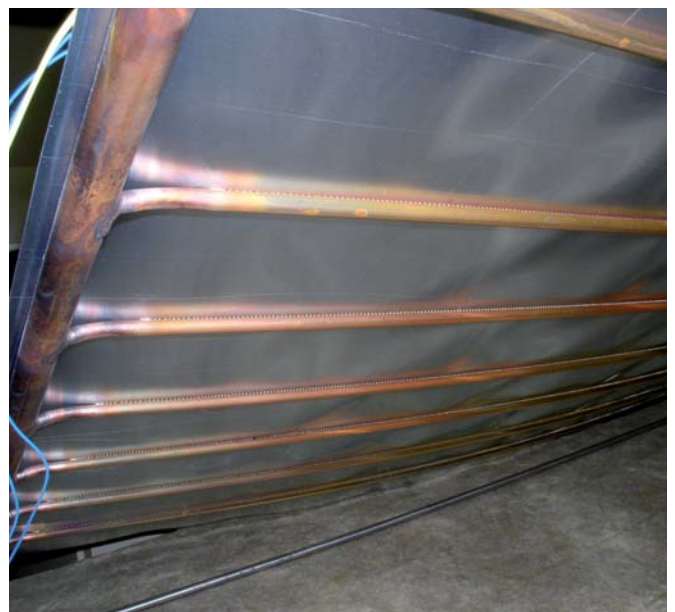
Figure 12: Backside of the absorber. All welded seams remain intact.

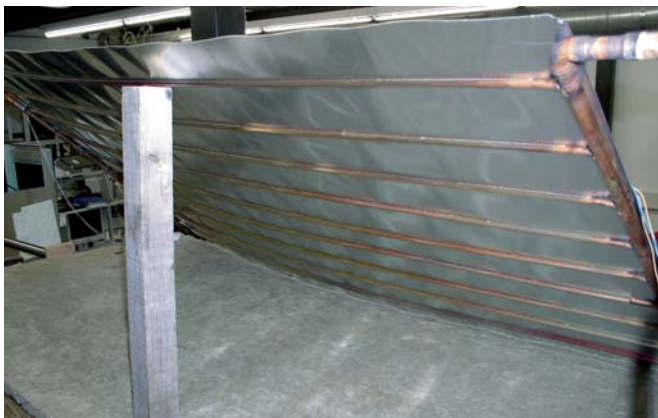
Figure 13: Backside of absorber following 1000th cycle.

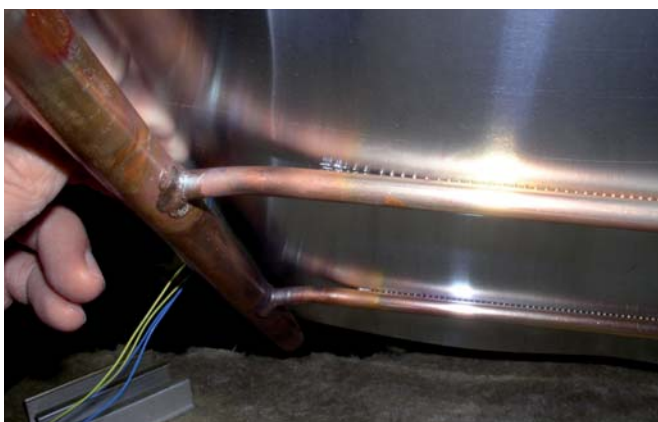
Figure 14: Mild separation of one of the ascending pipes.

A visual inspection was carried through following 1000 low temperature cycles. The welded seams appeared on (visual) inspection to be in order. On the end of one of the ascending pipes (Fig. 14) a mild delamination between aluminum sheet and copper pipe was apparent. Minor damage to the aluminum sheet was detected (Fig. 15) on closer inspection of the end of all welded seams. Given additional force or longer strain times these weaknesses could lead to larger scale flaws (crack-growth).

The delamination of the welded seam on the ascension pipe as observed following 1000 cycles did not worsen within the subsequent test cycles. The weakening at the ends of the welded seams also appeared to have stabilized by the 1000th cycle.

In this test a new procedure for a more rigid start and end weld pattern was tested. The conclusion of the minor separation and damage of the absorber sheet was that if too much laser energy is induced into the welding seam the rigidity of the aluminium absorber sheet can be reduced. An adjustment of this start and end pattern has shown no damage anymore.

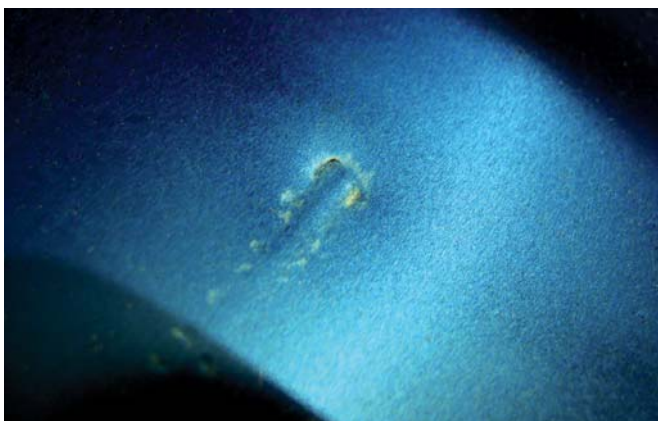
Figure 15: Mild damage of the absorber at the beginning of one of the welded seams.

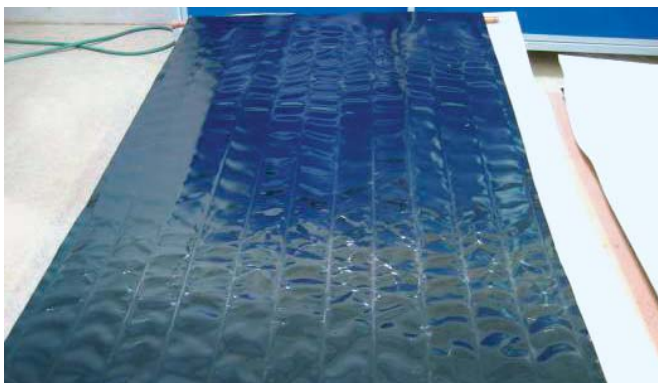
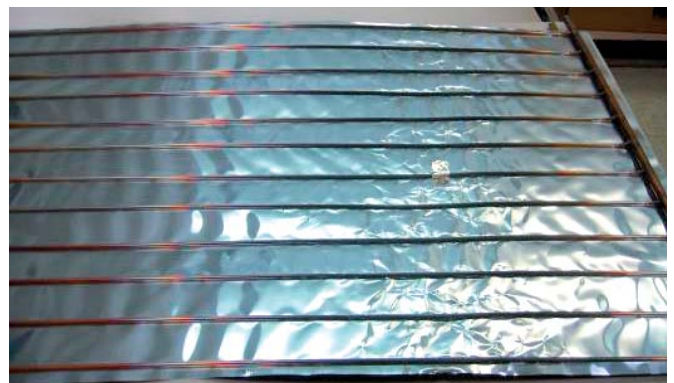
Images 1 and 2: Photo of the absorber after the shock test. Formation of ripples on the absorber plate.

With the exception of the ripples, no changes were found after the shock test. The result of the subsequent internal pressure test with 30 bars was also positive.

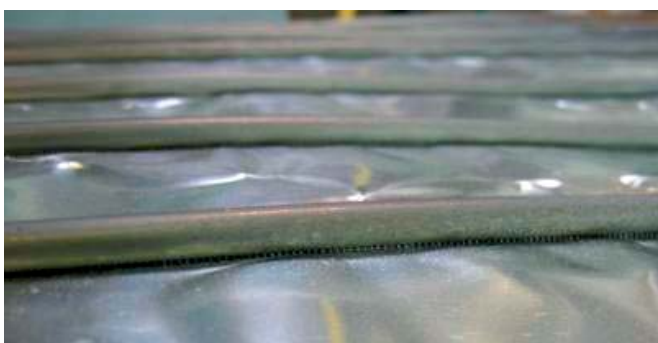
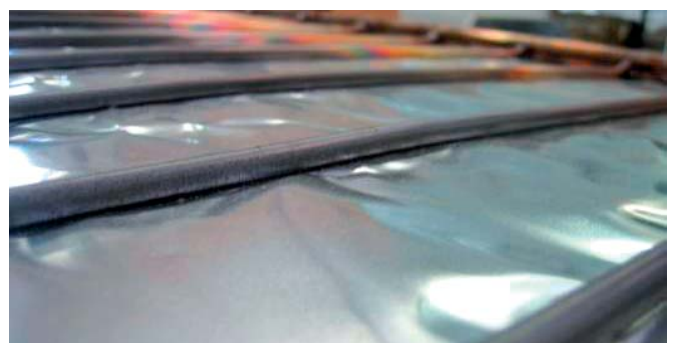
Images 3 and 4: Close-up photos showing the ripples on the absorber plate.

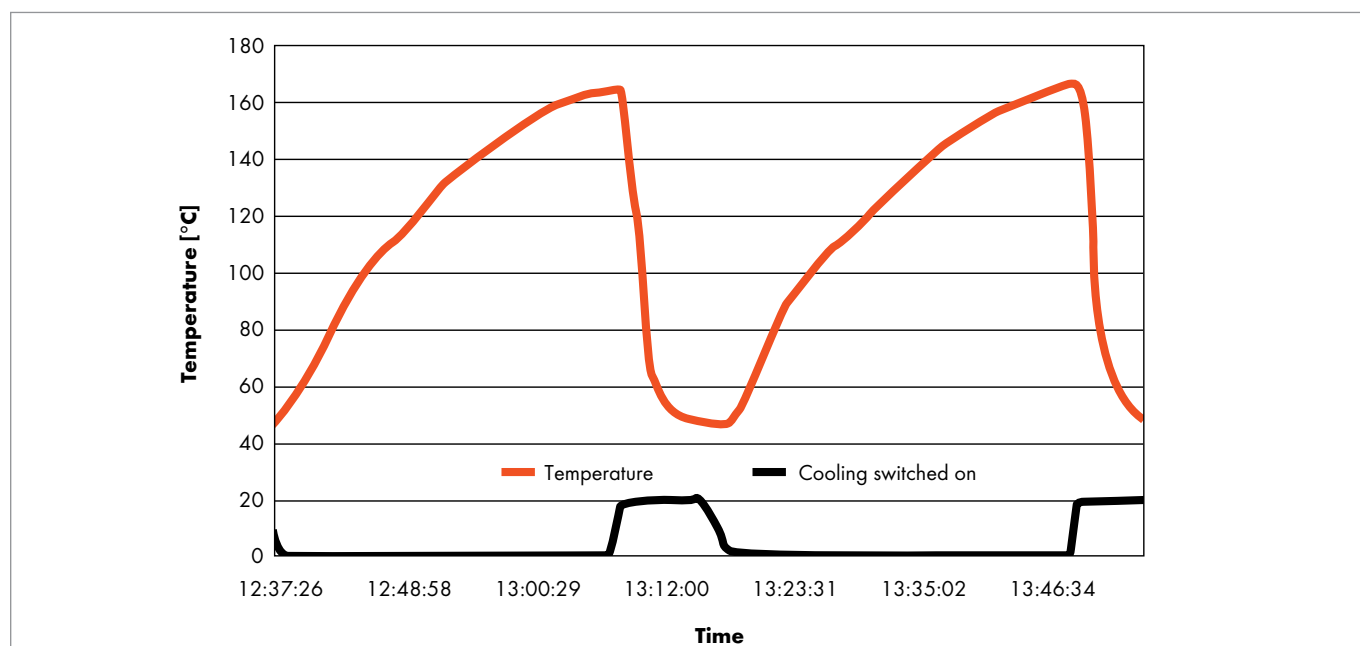
Result: Figure 1: Typical test cycle:

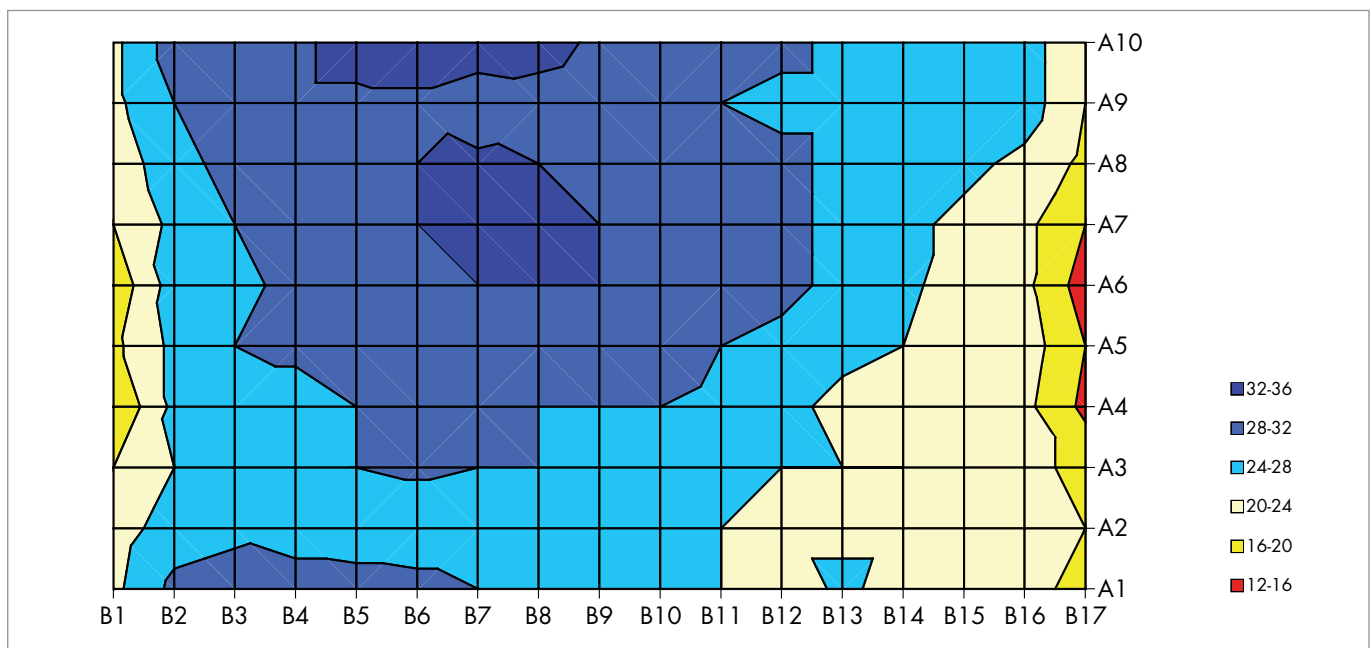
Result: Figure 2: Position of absorber surface after test:

Distance between glass bottom side and absorber surface in mm.

The absorber shows a remarkable deformation behaviour that was already observed in earlier tests: During the first temperature cycle the centre area of the absorber bends towards the glass. However, beginning with the second cycle, the deformation reverses and the absorber bends toward the back sheet. During the following cycles this deformation behaviour remains constant.

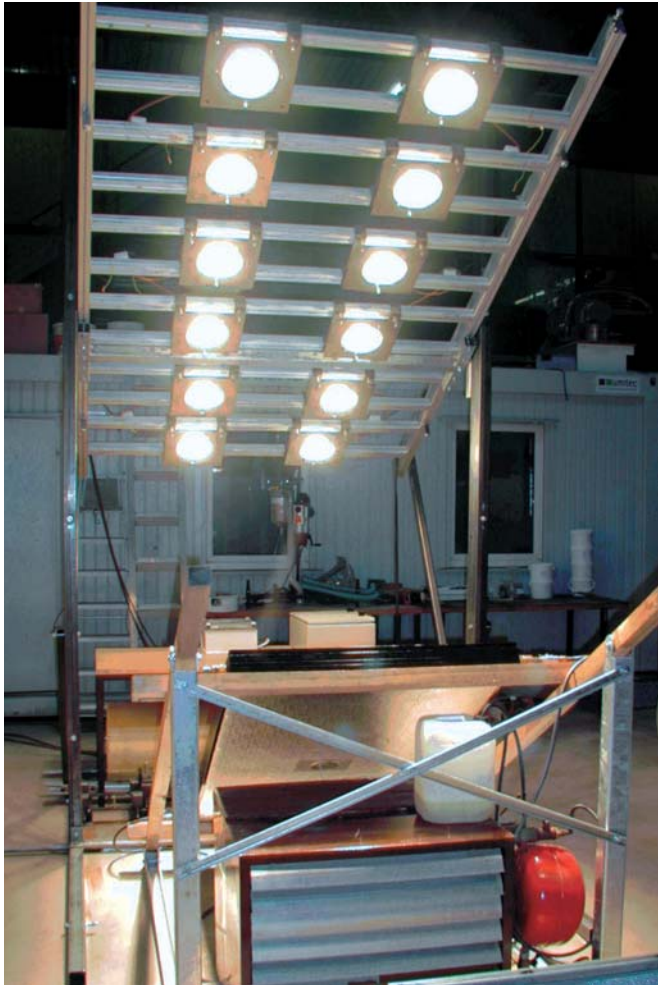
View of solar simulator

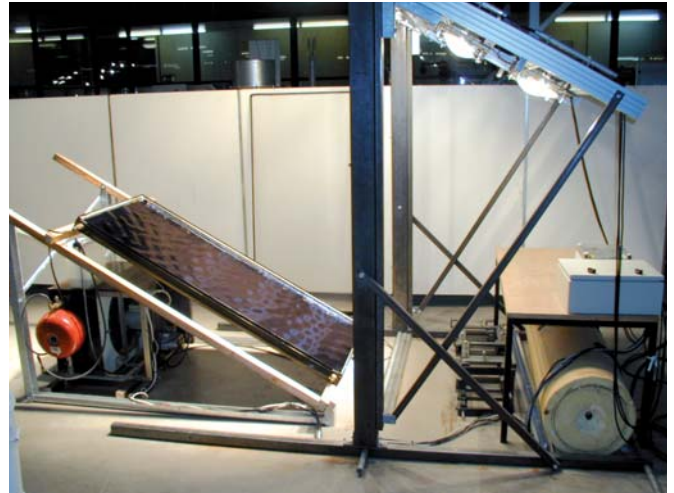
View of test setup

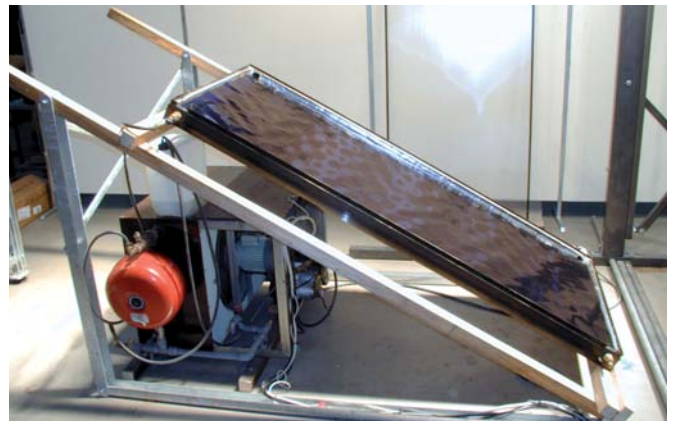
View of collector after exposure

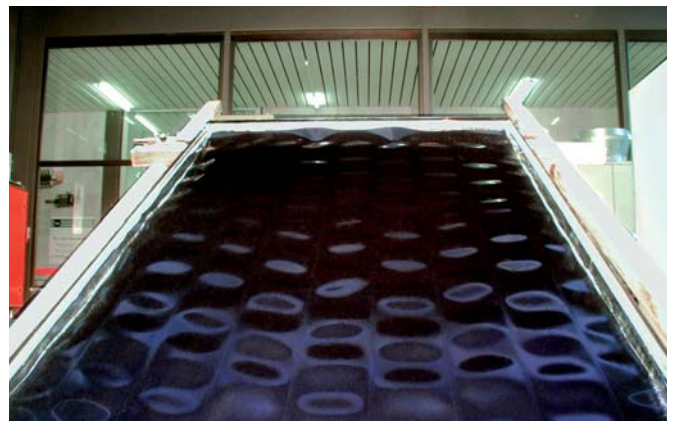
View of absorber after exposure

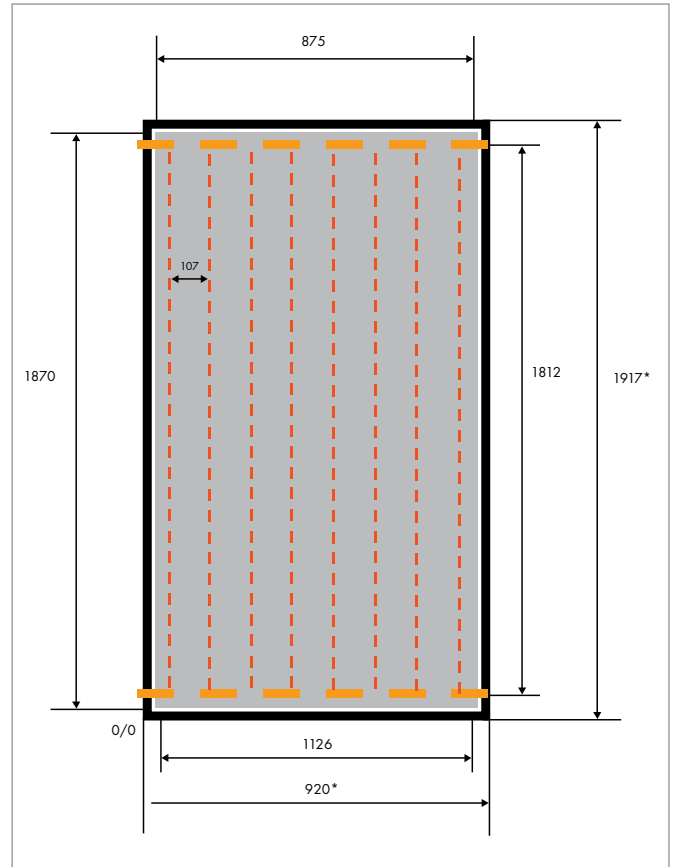
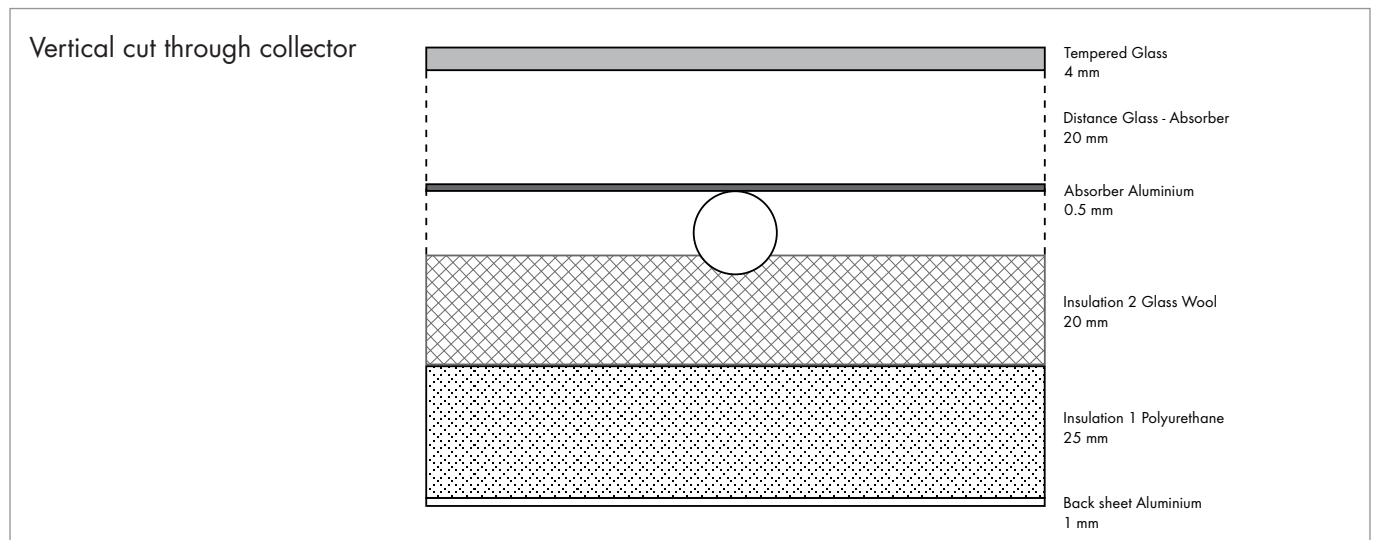
Absorber Substrat: mirotherm® 0.5 mm
Pipe grid: Copper F36 hard

- 0/0 Coordinates for distance measurement (see separate table)
- * Outer dimensions collector frame
- Copper riser da = 16 mm laserwelded on aluminum sheet
- Copper header da = 25 mm not laserwelded

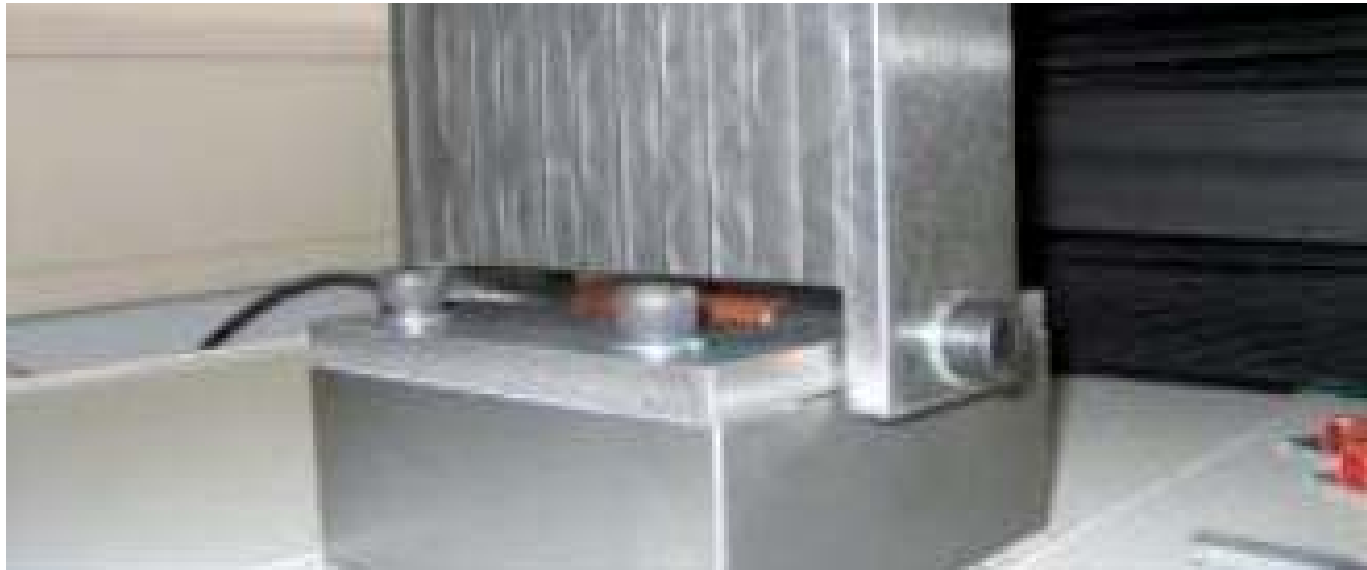
Photograph 1: Test setup

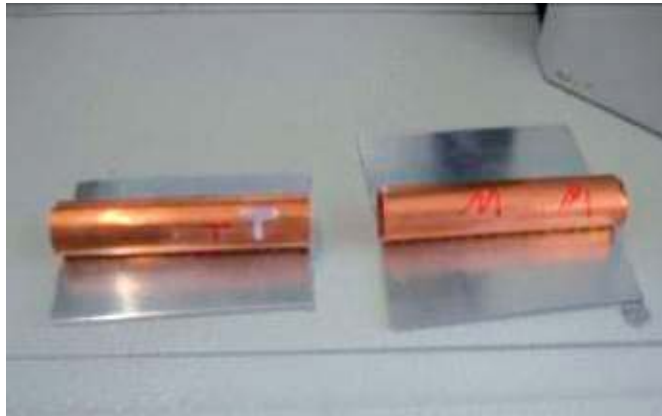
Photograph 2: Welding sample – before test

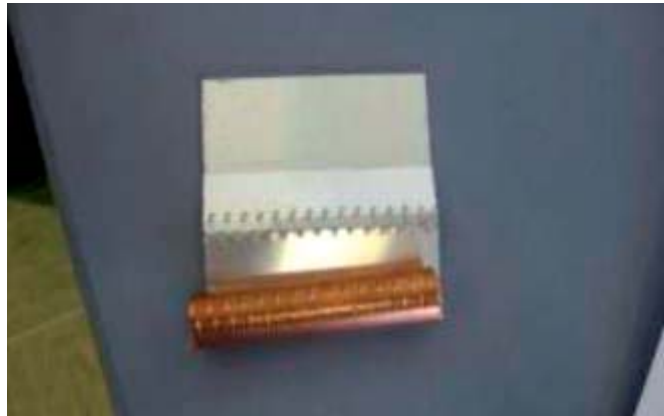
Photograph 3: Welding sample – after test

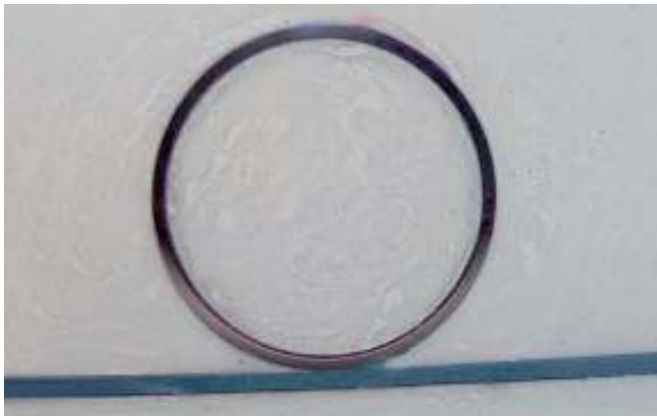
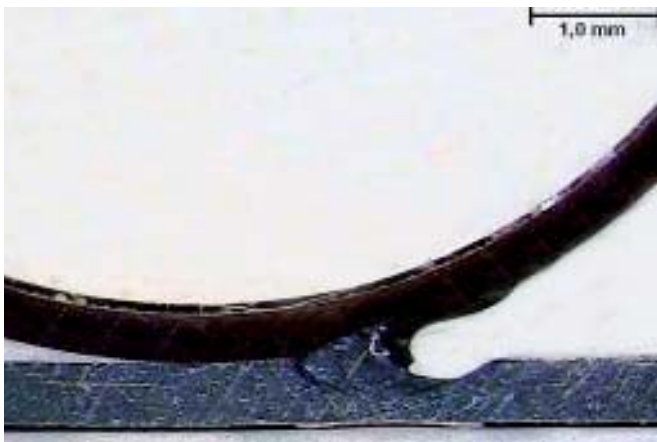
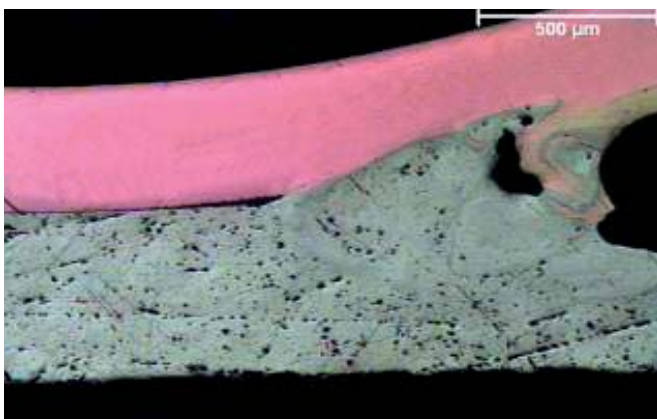
- The strength of such a welding joint is mainly due to the mechanical bonds in the melted areas.
- Metallographic examinations are thus not suitable for a comprehensive evaluation of such a joint.
- The weld is best investigated using mechanical tests such as the pull-off test.
- The extent of melting on the copper tubing and aluminium plate is up to half of the wall thickness of each material.
- The minimum weld-point diameter of approximately 1 mm is fulfilled.
- No melting/damage to each of the rear sides due to weld roots has occurred.
- 'Burning-through' of tubing or plate must be avoided and was avoided.
- A leakage test is a good test of the maximum pressure that can be withstood after the welding process.
- Heat transmission (f-factor) must be tested separately.

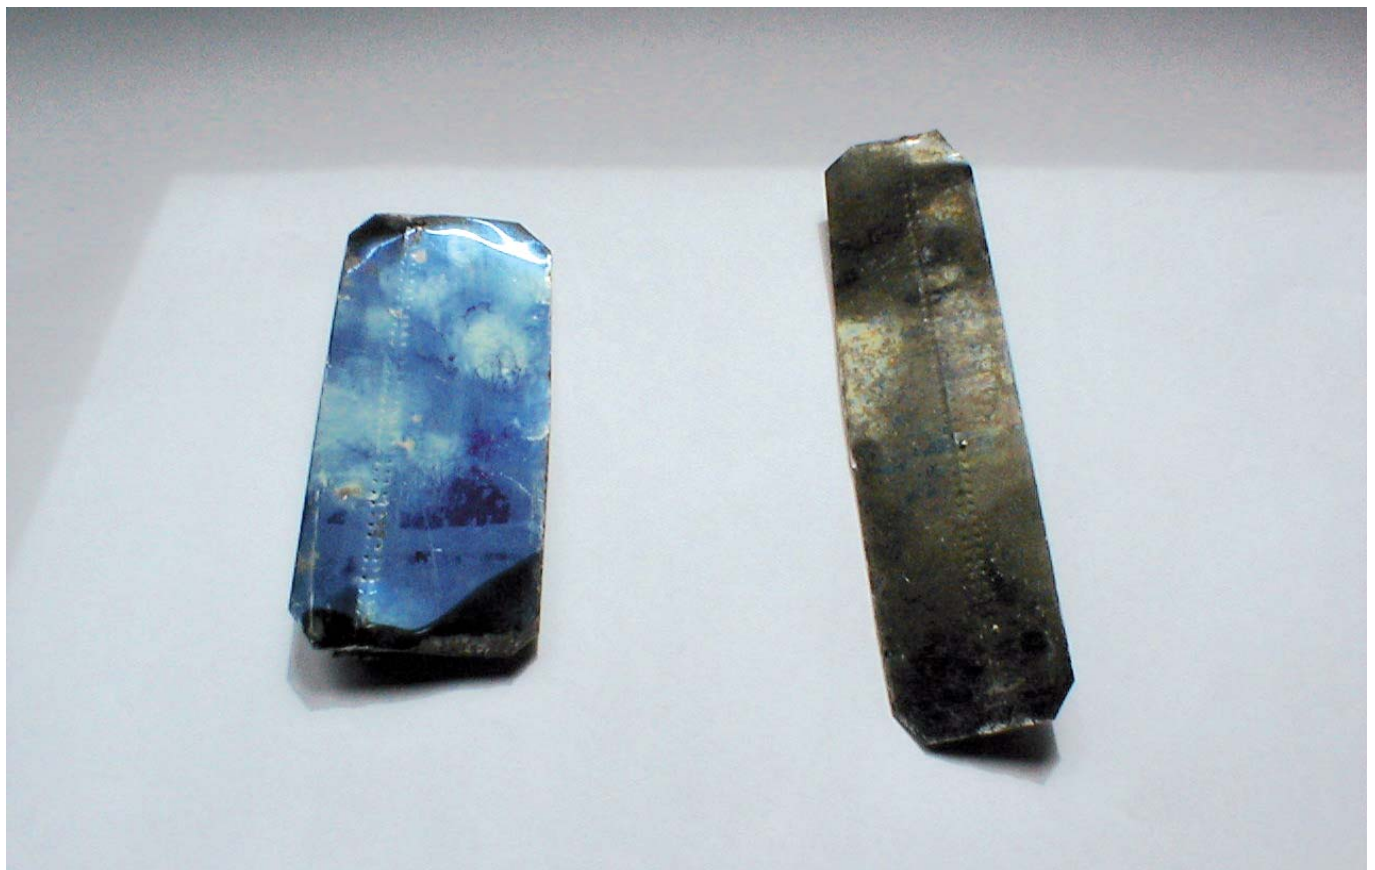
One has been put in the wet room DIN 50017 (40°C 100% humidity) for 240 hours : no damages, the other has been put in the salt mist test ISO 9227 (35°C 100%

humidity 5% NaCl) for 240 hours: few damages of the selective coat , no corrosion problems on the copper aluminium junction

Front side

It is obvious that such a harsh test will do damage to any selective coating. The important outcome of this test is that no galvanic corrosion occurred in between copper pipe and aluminium sheet.

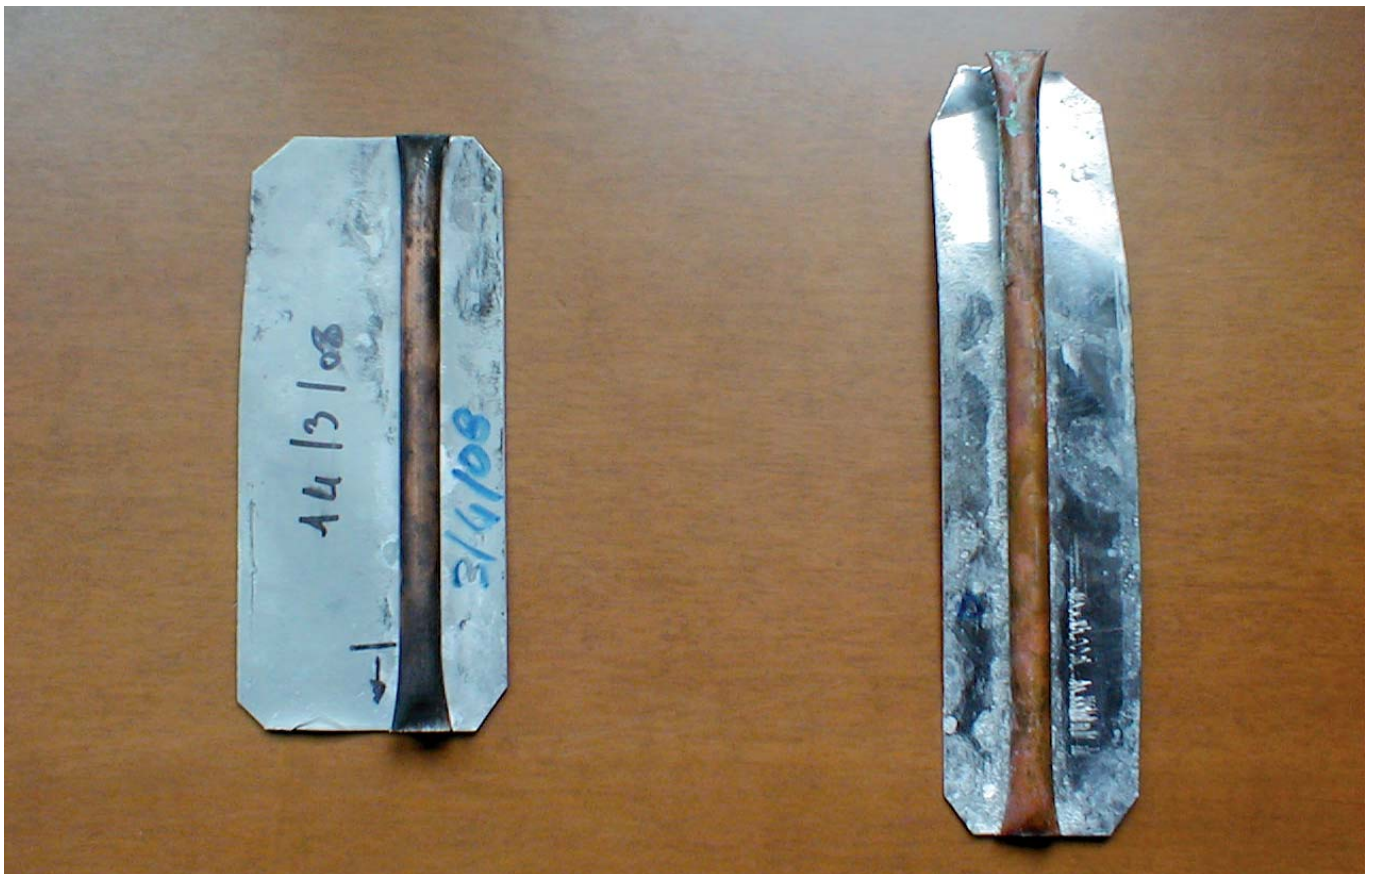
Reverse side

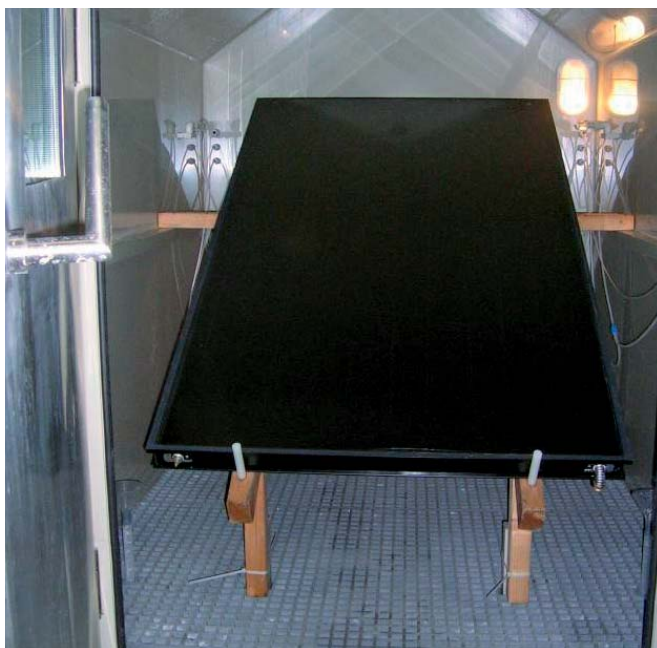
Picture 9: Set-up of collector in test chamber

<p>Anordnung des Prüflings während des Tests (siehe Bild 9) <i>Arrangement of test specimen during the test (see picture 9)</i></p>	<ul style="list-style-type: none"> • Neigung: 30° zur Horizontalen • <i>inclination: 30° to horizontal plane</i>
<p>Beanspruchungsdauer <i>Duration of test</i></p>	<ul style="list-style-type: none"> • 96 Stunden (4 Tage): 2.11. - 5.11.2007 • <i>96 hours (4 days): 2.11. - 5.11.2007</i>
<p>Nachbehandlung <i>Post treatment</i></p>	<ul style="list-style-type: none"> • Absprühen des Prüflings mit Wasser • Sichtkontrolle des Prüflings • Überprüfung der Wärmeleistung durch vereinfachte Leistungsprüfung bei zwei charakteristischen Temperaturen • <i>test specimen was sprayed with water</i> • <i>visual inspection of test specimen</i> • <i>examination of thermal performance by means of simplified thermal performance test at two characteristic temperatures</i>

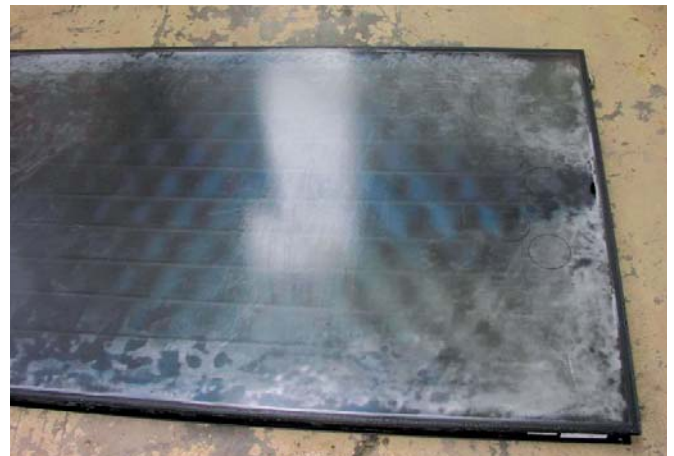
Picture 10: Humidity on the glass due to condensate inside the collector

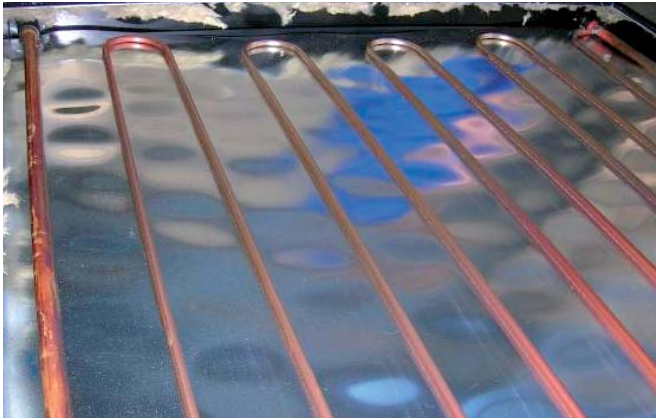
Bild 21: Verbindung Kupferrohre / Aluabsorber
Picture 21: Connection copper tubes / alu absorber

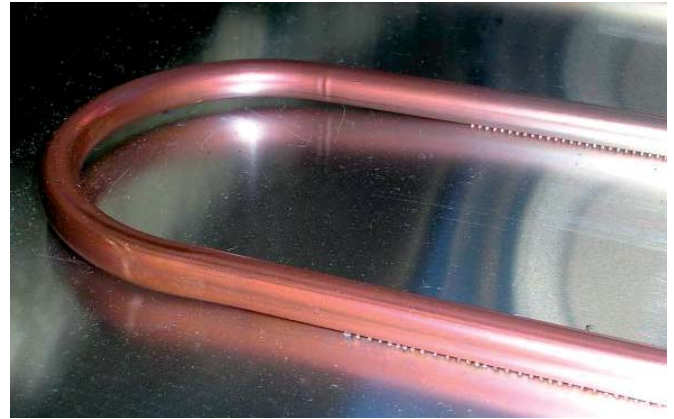
Bild 22: Absorber: Bogen Mäander
Picture 22: Absorber: Arch meander

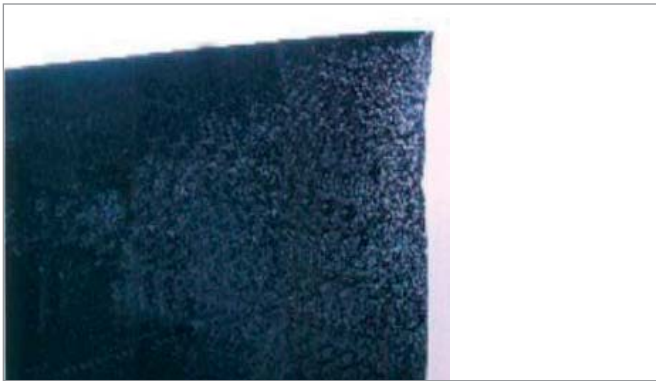
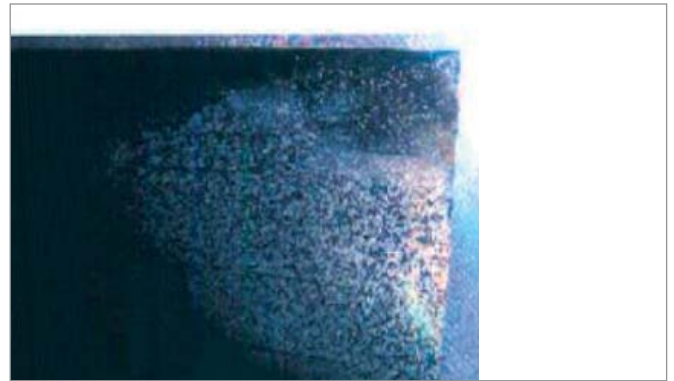
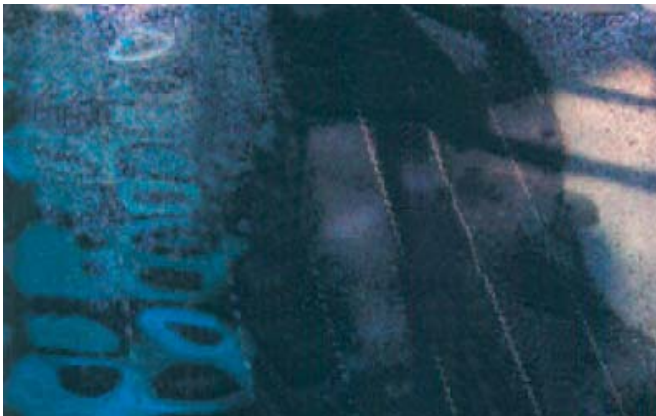
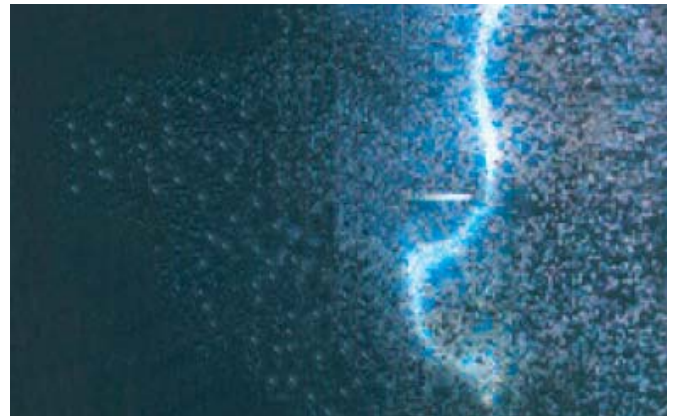
Bild 24: Verfärbung Absorberbeschichtung
Picture 24: Discolouration absorber coating

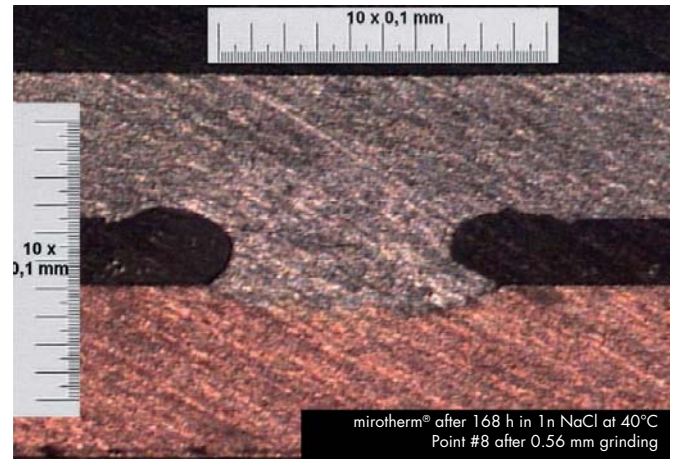
Picture 4

As documentation, Picture 4., to the same magnification as Picture 3., along the joint (copper tube) axis is shown. This picture is after the 168 hour test has been carried out, and it is clear to see that absolutely no corrosion of either the copper tube to the aluminium around the joint has taken place.

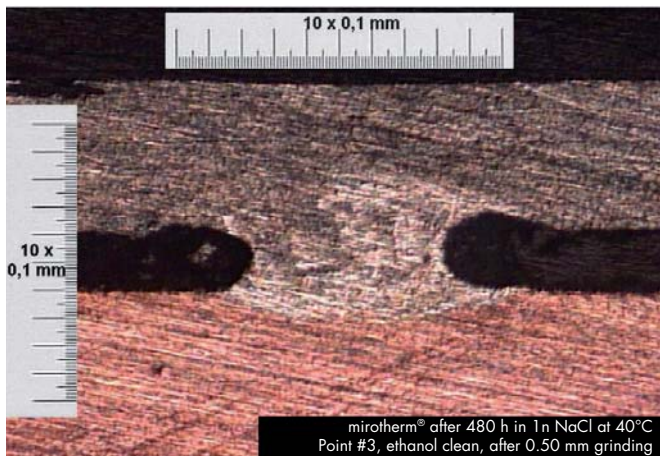
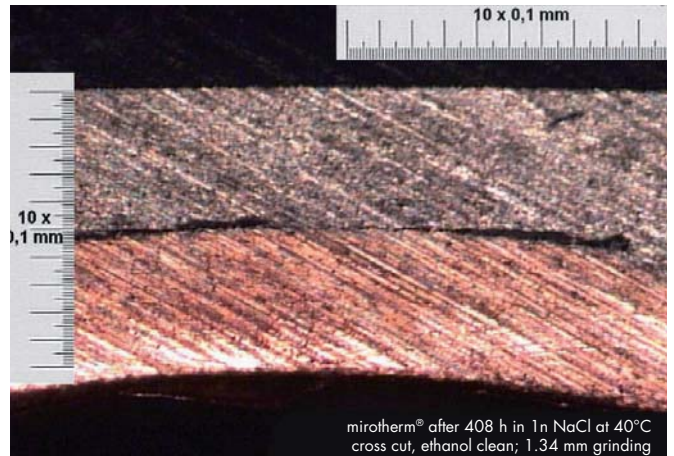
Considering the results obtained after the 168 hour salt water test, we extended the immersion time to 408 hours, and carried out the same metallurgical examination. Picture 5. shows the result as does Picture 6, through the joint but across the tube axis. In the laser welded zone where also metal intermixing takes place, there is no corrosion to be seen.

After immersion in salt-water for 408 hours, no galvanic corrosion can be detected at the laser-welded joint between the aluminium absorber plate and a copper tube. This confirms the absolute integrity of the laser-welded joint between mirotherm® and a copper tube even after heavy corrosive load.
