mirotherm® absorber fact book

Table of Contents

2.1 Test Report No. X111

Customer: Wagner & Co. Solartechnik GmbH – Long term load testing:
Laser welded Cu-Alu absorber thermal-shock test procedure (on arrangement).

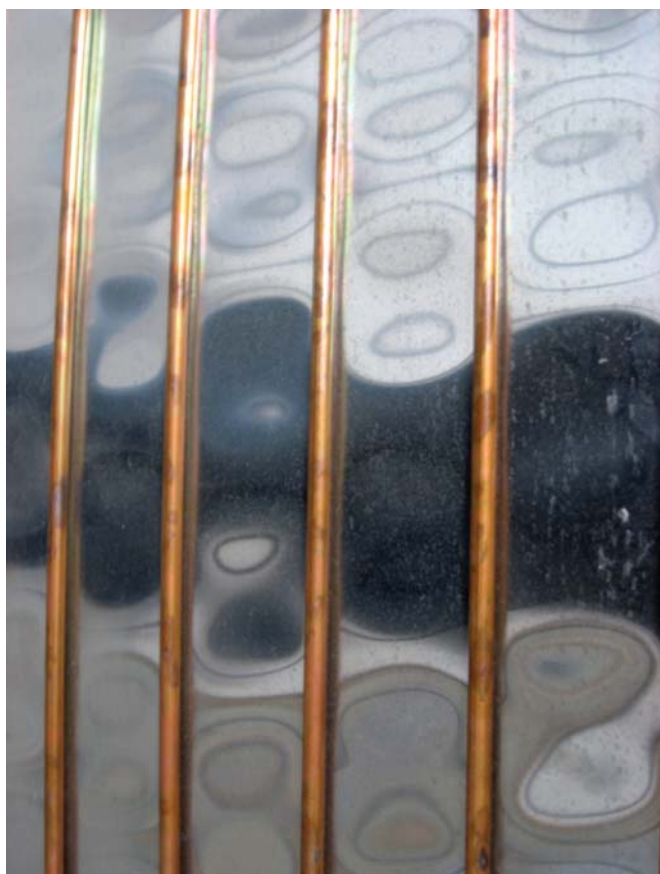
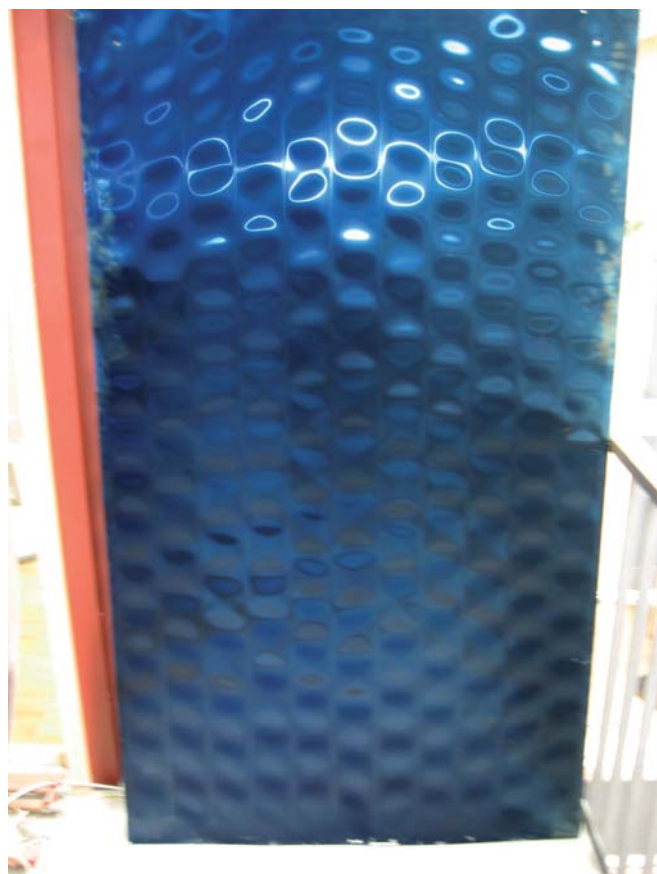
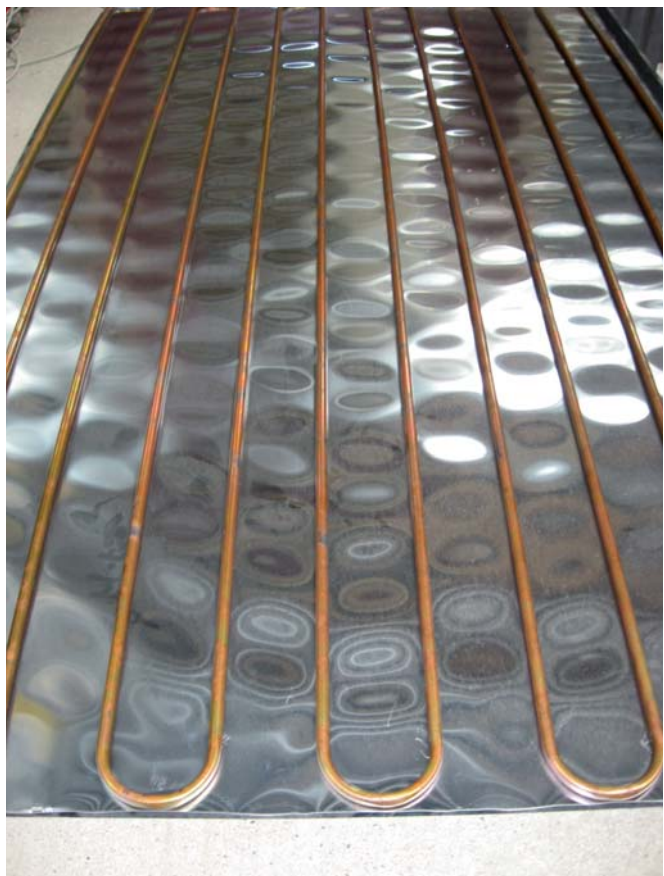
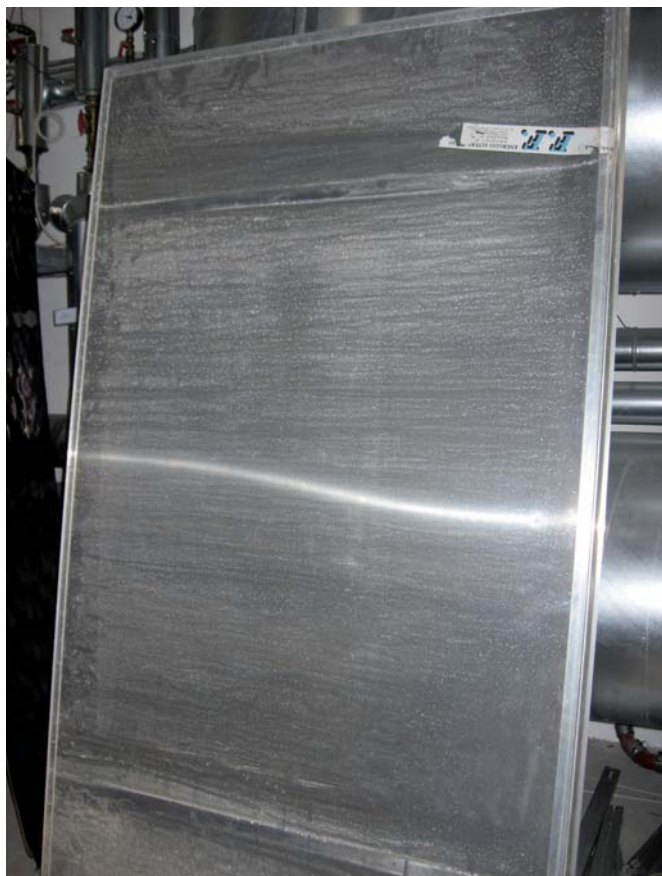
Sample photographs Solvis Cala / southwest coast of Portugal

The photographs intentionally show the dirt which has accumulated. See also the collector housing.

No signs of corrosion can be detected on the front or rear of the absorber, and the welding and contact points are also free of corrosion.

No loosening or separation of welding points is present, meaning that the copper-aluminium laser-welded joint is fully intact.
